New Attempt to Maintenance of Steel Bridge Coating in Expressway

Abstract

In the steel bridge of the expressway in NEXCO, most of the rust prevention and protection method is painting. To reduce cost of the painting maintenance, the realization of an effective painting repair technique is necessary.

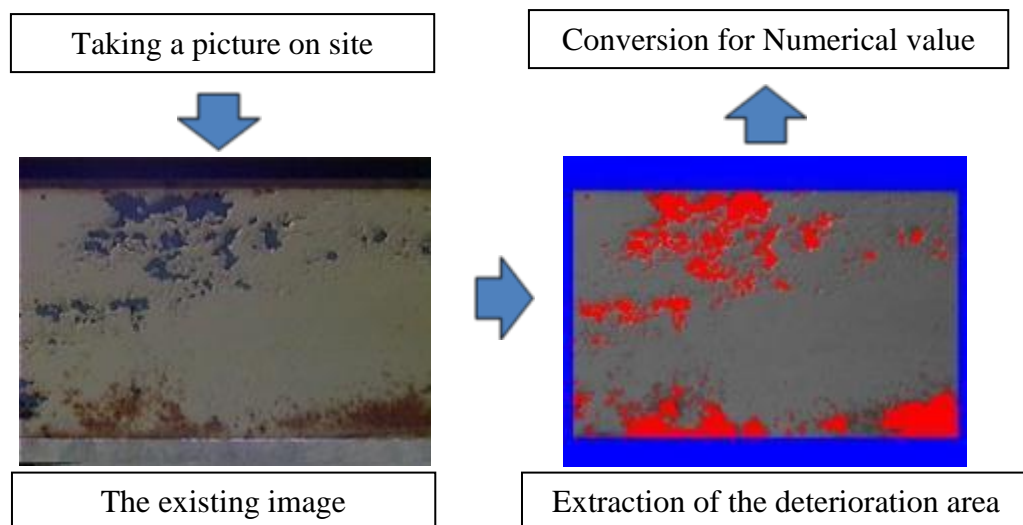
For maintenance of the painting in NEXCO, Paint View System have been used. Paint View System detects the deteriorated coating with photograph, and it can judge necessity of painting repair from deterioration forms and the deterioration area ratio of the coating (Fig.3).

Fig.3 Detecting the deterioration area of painting using NEXCO Paint View System

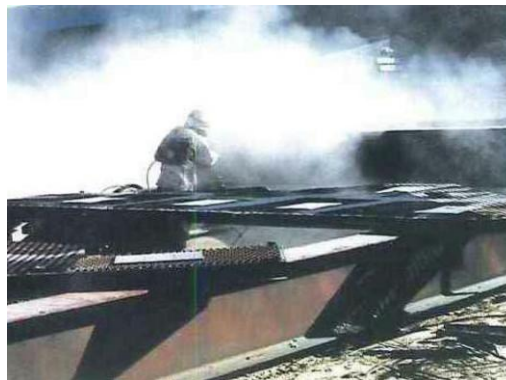
Because of its results, surface cleanliness method by blasting (According to ISO 8501-1 Sa2.5) has been focused recently. (Fig.7)

Fig.7 Cleanliness processing by blasting(According to ISO 8500-1 Sa2.5)

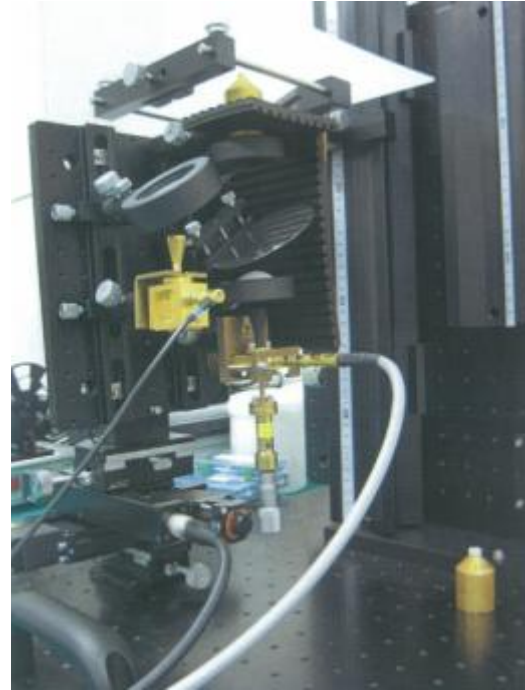
The examination was carried out in collaborative investigation with Iwate Prefectural College. The testing equipment used an apparatus as shown in Fig.8, and carried out the examination on a condition as shown in table 1.

Fig.8 Terahertz Imaging system
(Iwate Prefectural College owned)

Item	Contents
Measuring system	Reflection imaging (probe scan)
Oscillation element	TUNNET 170GHz
Detector	0bias SBD at RT
Measurement area	Depends on each examination (about 60mm×60mm)
Scan size	0.5／1.0mmstep
Stabilization condition	8e-5, avg1 or 2

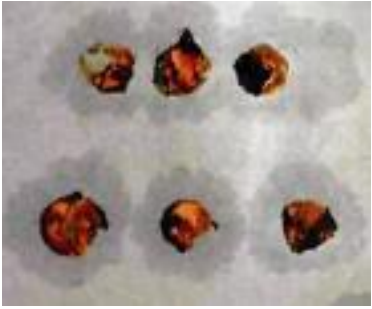
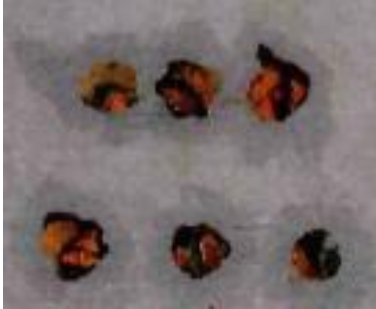
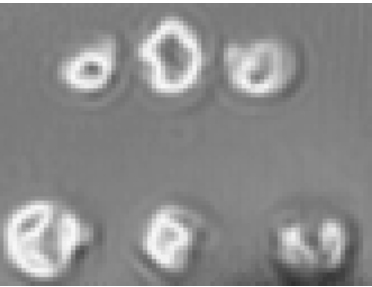
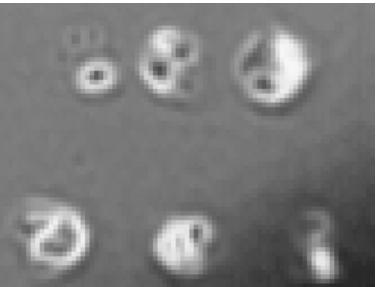
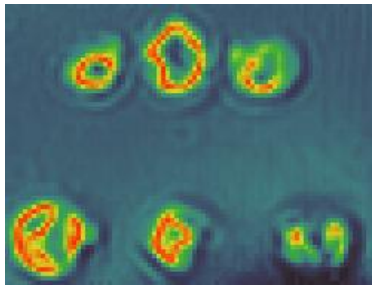
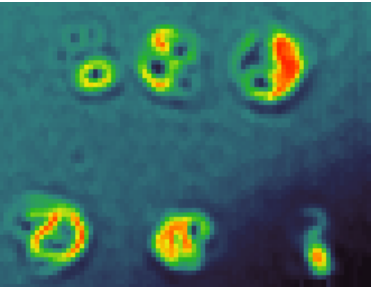
The result of the terahertz imaging is shown in Fig.11. As a result, for both specimens of the “a-1” painting system and the “c-3” painting system, the rust area can be detected enough precisely.

Example of middle size diameter	
	Painting system“a-1”	Painting system“c-3”
Rust Type

Imaging (Gray scale)

Imaging (Color)

Fig.11 Terahertz imaging of the specimen

Some absentminded point was seen partially. Because there is the place where strength of receiving wave is very week, so it seems the rotation of this area becomes hard to relatively distinguish it. However, the difference of the detection performance by the kind of painting specifications is small by this test result.

Seeing the results of other parts, an imaging of big rust area was clearer than the small rust area case. In addition, there was not combined every rust area. (The smallest distance between the rust is 5mm) Therefore, this method can be distinguished an individual rust area.

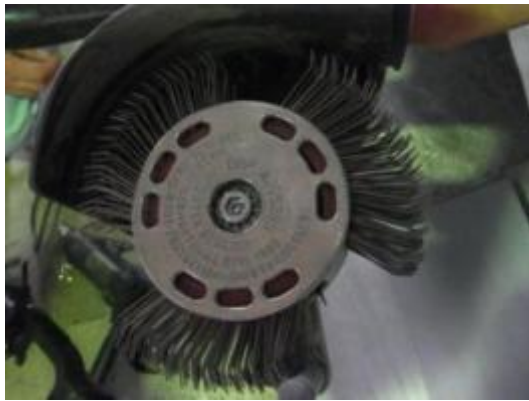
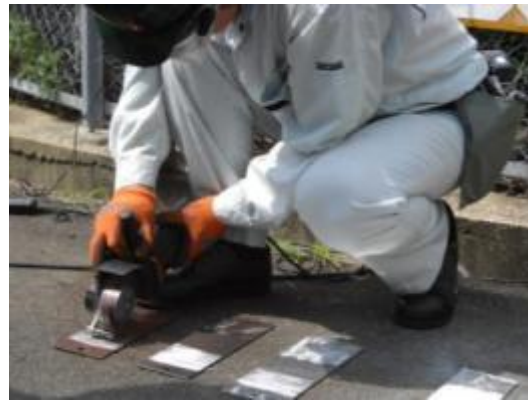
So we studied that the method which has been used in the field such as automotive, marine, plant recently, and can remove the rust as well as blasting method, can be applied to repair the steel bridge coating on site. The method need a special tool that named Bristle Blaster®(Fig.15), and developed in Germany. The principle of surface cleanliness is striking the subject with the many carbon spring steel or stainless steel spinning wires. The method with this tool can be the surface cleanliness as well as according to ISO 8501-1 Sa 2.5, as are also achieved for conventional blasting^{9~11)}.

Fig.15 The Special Tool of New Blasting Method

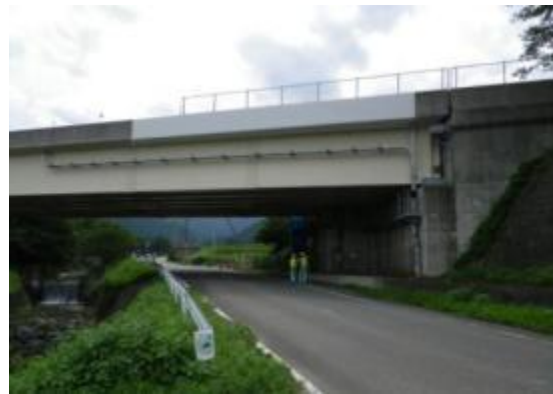
The test construction carried out at the steel bridge of Ise Expressway in Mie Pref. The bridge had the local deteriorated coating at the end of girders, because of the influence of leakage water in deicing salt from the expansion joint (Fig.16). In the test, we investigated the surface roughness, dust, noise, cleanliness performance at the web, corner, gusset plate and the corrosion surface, and processing time on the bridge repair construction site.

Fig.16 Horisaka Bridge (Ise Expressway in Mie Pref. conventional general paint 23years)

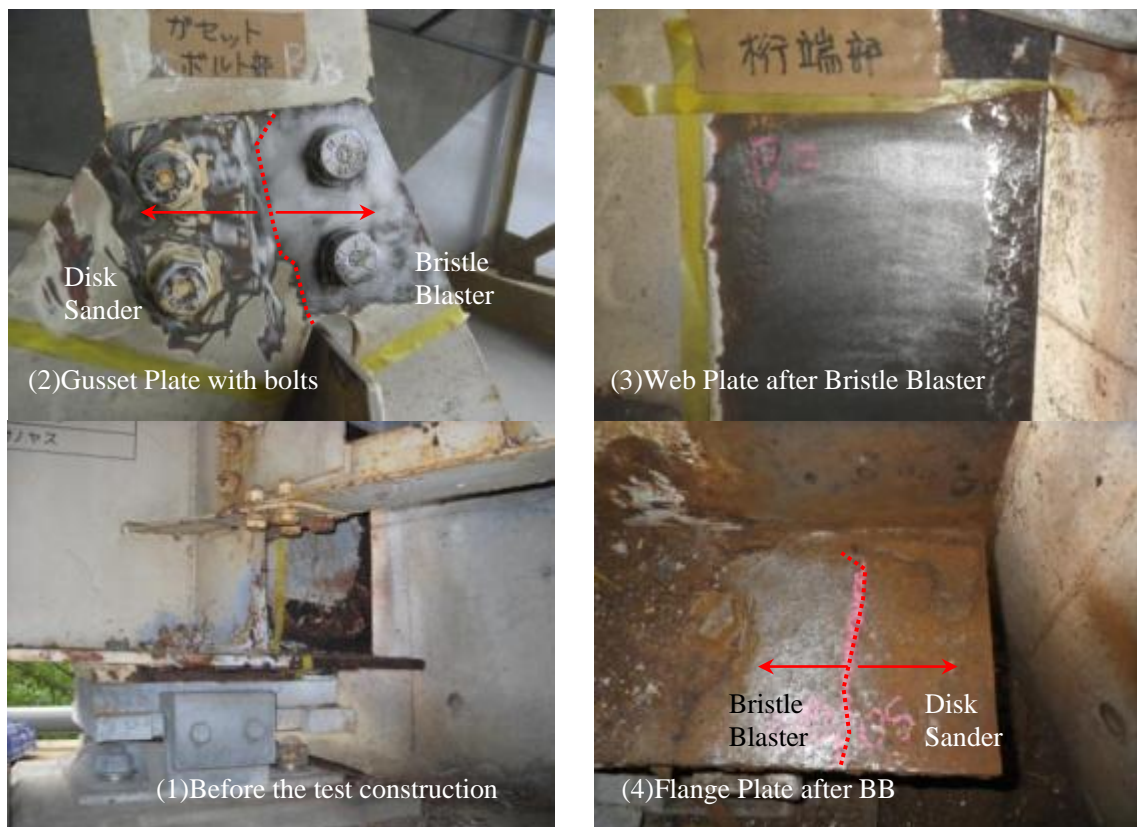
Fig.19(1) to (4) shows the treated surfaces after the work. This method is not worrying about cutting down the steel, the variations of surface cleanliness treatment is not much. Also, it can be good at the corner and around the bolts. Grinding with disk sander cannot be so. In addition, it can clean all the sever rusts (partial layered) on the corroded steel surfaces.

Fig.19 Treated Surfaces after the tests
